TABAS-E-GOLSHAN (IRAN) CATASTROPHIC EARTHQUAKE OF 16 SEPTEMBER 1978; A PRELIMINARY FIELD REPORT

*Manuel Berberian**
Department of Geodesy and Geophysics
University of Cambridge, Madingley Rise, Madingley Road
Cambridge CB3 0EZ England

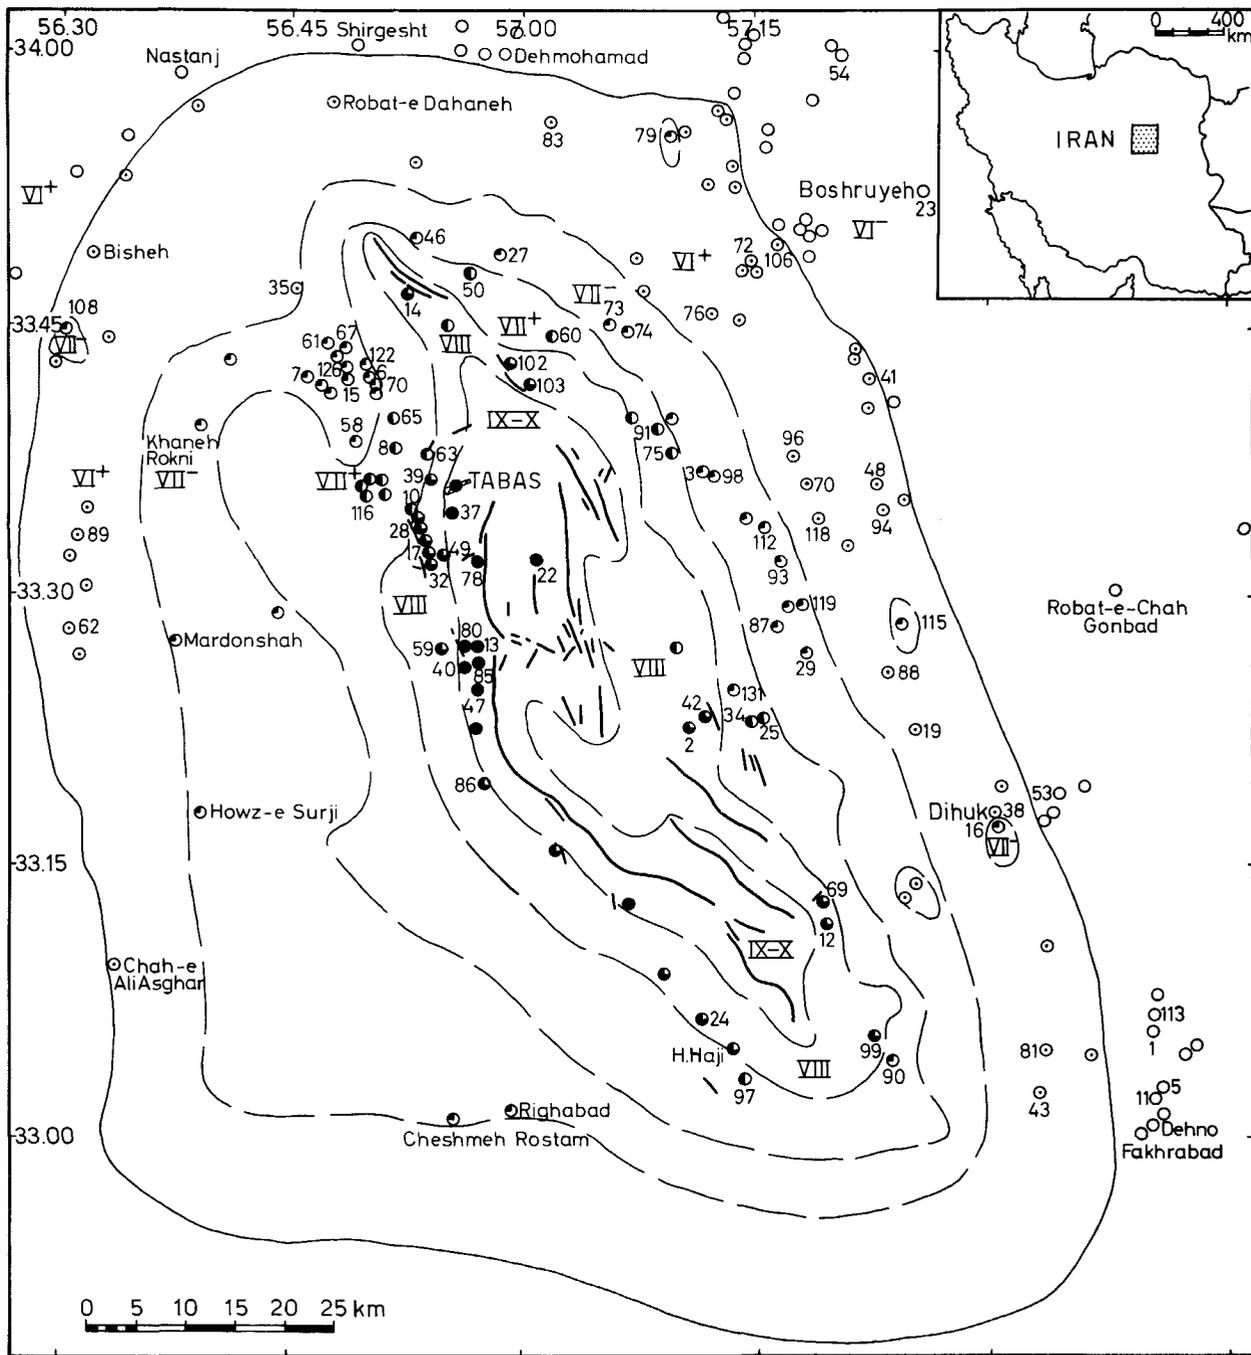
— SURFACE RUPTURE ASSOCIATED WITH 1968 EARTHQUAKE ; ISOSEISMAL ON M.M.I.S. ; ● 80-100% DESTRUCTION, ● 50-80% , ● 35-50% , ● 20-35% , ● 5-20% , ○ 5% DESTRUCTION ; 56 NUMBERS REFER TO THE NAMES OF THE VILLAGES GIVEN IN THE TABLE.

Fig. 1. Isoseismal map and damage distribution in the epicentral region of Tabas-e-Golshan earthquake of 16 September 1978.

Although the earthquake took place in a sparsely populated and remote area, it destroyed or severely damaged ninety villages together with Tabas town, slightly damaged another fifty villages and demolished more than 15,000 housing units (Table 1 and Fig. 1). Had the earthquake happened in a populated area such as Tehran, the casualty figures and destruction would have been infinitely greater.

There was a clear correlation between the surface rupture associated with the earthquake and the areas of earthquake damage. Destruction and damage decreased at distances from the fault (Fig. 1). The intensity values assigned to the damage area ranged from VI to X on the Modified Mercally Intensity Scale. The highest intensity of IX-X (80-100 % destruction

with 50-85 % casualty of the inhabitants) covered an area of about 800 km² and was experienced approximately for 80 km along the ground rupture and roughly about 3 km on either sides of it (Table 3 and Fig. 1). The very damaging intensity of VIII (50-80 % destruction with 10-30 % casualty of the inhabitants) covered an area of 1000 km² and was generated for 100 km along the earthquake fault and roughly 10 km from it. The damaging intensity of VII (20 - 50 % destruction) covered 3600 km² and extended for 110 km along and about 60 km across the fault. The approximate limit of the building destruction and severe damage stopped about 45 km away from the ground rupture (see Table 3 and Fig. 1).

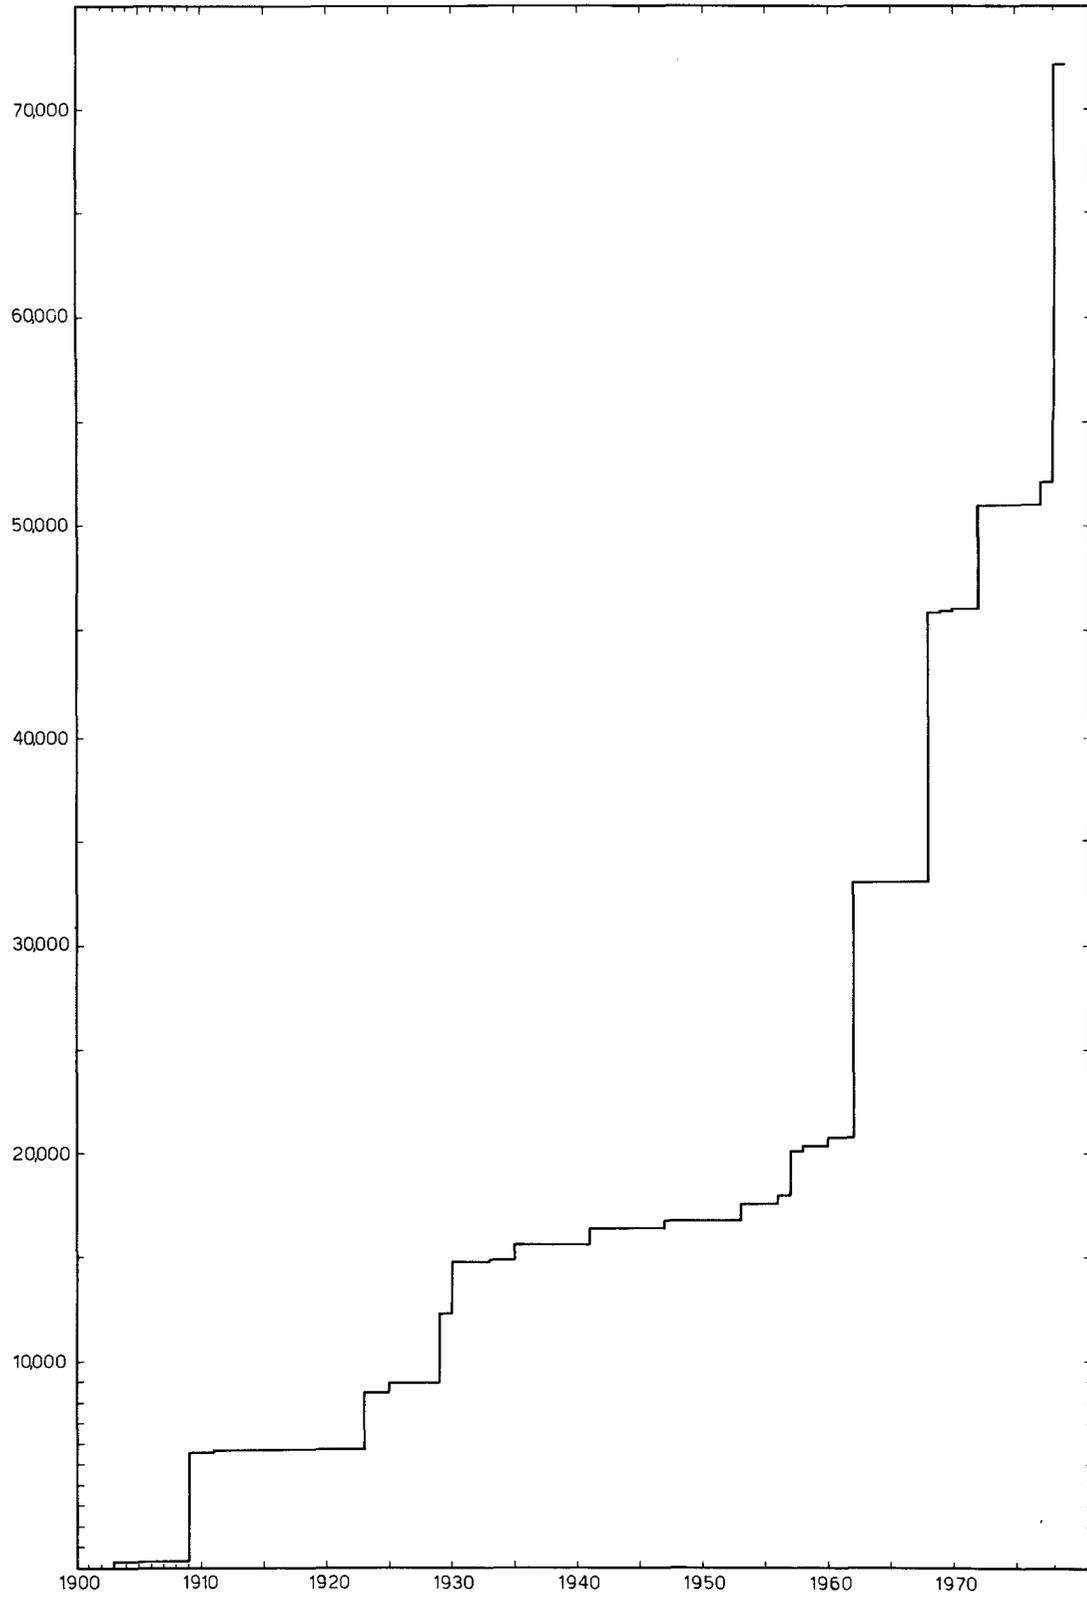
Fig. 2. Total number of deaths during Iranian earthquakes from 1903 to 1978 (also see Table 2).

Iran is situated in a highly seismic part of the world, and has been frequently struck by catastrophic earthquake during recorded history. These earthquakes have resulted in great loss of life, and, in rendering large numbers of people homeless and disrupting the agricultural and individual basis of their lives, have been wasteful of national resources. Probability of earthquake occurrence and high magnitude of resultant damage and destruction is high and should be taken very seriously. Since the beginning of this century at least 72,222 people have lost their lives during earthquakes in Iran^{2,3} (Fig. 2 and Table 2).

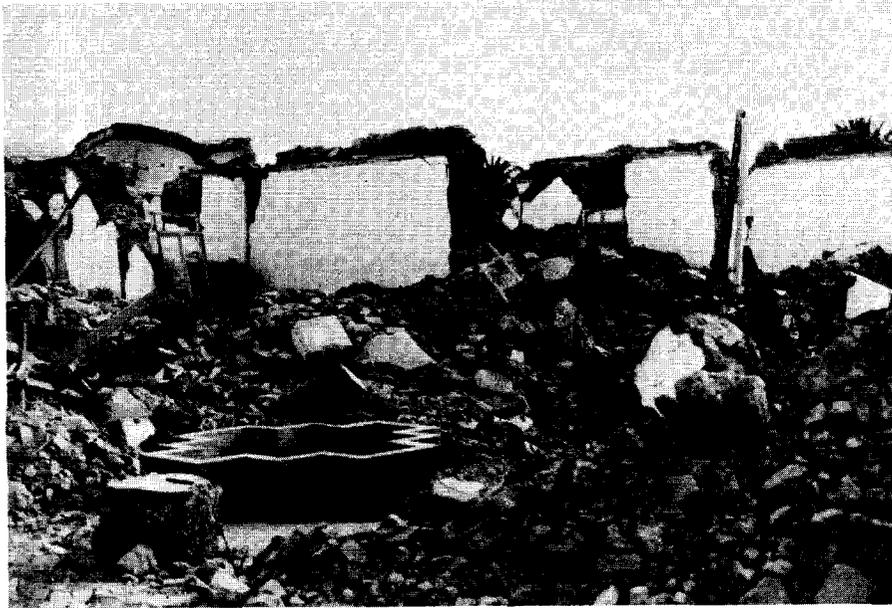
Fig. 3. Steel-beam jack-arch roof constructed on the adobe walls in Tabas is completely collapsed during the earthquake.

in situ cast sun dried clay bricks or a mixture of stone and mud. In Tabas great care was taken by the officials to preserve the original adobe structures of the old and traditional style by enforced building codes. For this reason the steel-beam jack-arch roofs were built on top of the sun dried mud brick walls (Fig. 3.). These walls, unable to sustain the lateral forces of the earthquake, were completely destroyed. All the adobe houses in the earthquake region were completely destroyed or damaged beyond repair. However, the proper brick masonry buildings suffered far less damage.

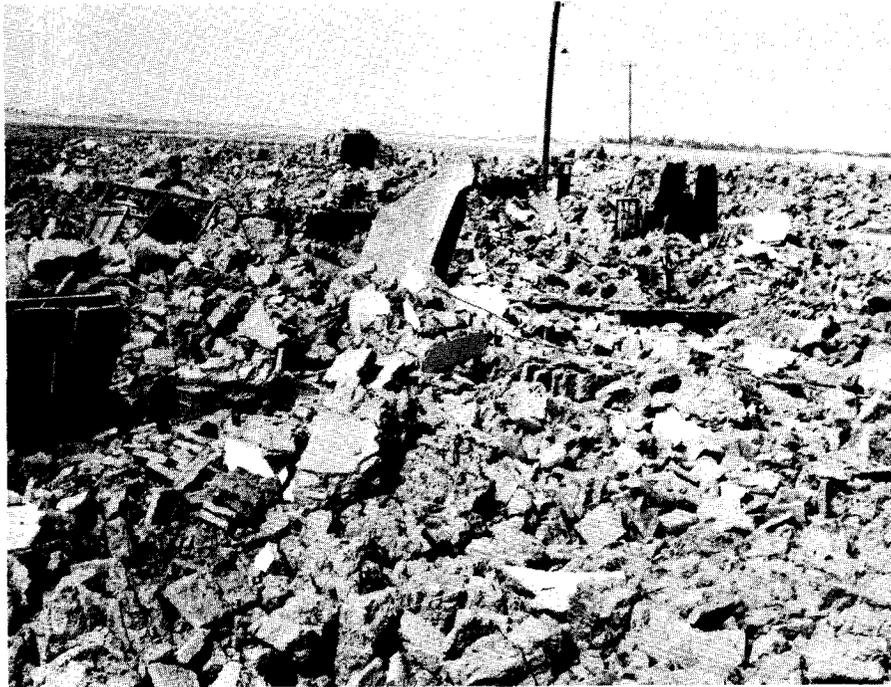
Fig. 4. Complete destruction of the adobe houses in Korit village south of Tabas (No. 80 in Fig 1 and Table 1).

The adobe brick constructions with domed or wooden beam roofs together with the stone masonry houses with clay mortar, comprise 98 % of the houses in the area (Fig. 4). The walls are of adobe brick and clay mortar, and the roofs of wooden beams or domed, covered by clay and straw and tamped earth. New layers are added annually to the roof as a protection against rain and snow percolation. The houses are very simple in plan and do not rise higher than the ground floor. They cluster together to form settlements (Fig. 5). Occasionally the settlements show the more orderly arrangements of a village with narrow streets and joined houses. In masonry houses, usually rounded stones of different sizes are used with clay mortar. Most of these constructions are now completely destroyed, or are seriously damaged and unsafe as dwellings (Figs 3, 4 and 5). In Tabas, the kiln bricks were used for facing the external walls of adobe houses without any adequate connection between them. It was observed that cracks usually started from the corners or openings in houses and progressed into the walls, causing the collapse of the heavy roofs.

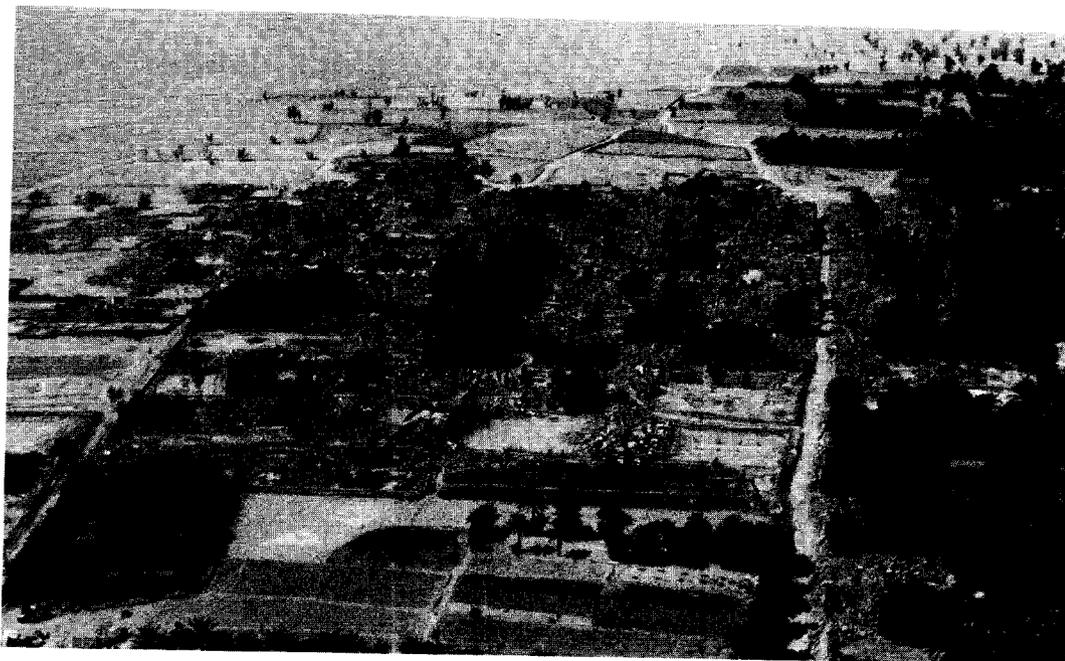
Fig. 5. Aerial view of Fahalanj village (No. 47 in Fig. 1 and Table 1) with complete destruction of adobe houses. Note a few dome vault houses which stood up during the earthquake.

The high ratio of death to injuries emphasizes that the traditional adobe houses of the devastated region, with their weak walls and heavy earthen roofs, offer little resistance to shocks. Even an earthquake of much lower magnitude could cause the same disaster. Since the villagers cannot afford to use better or expensive building materials to build their houses, the traditional adobe constructions should be redesigned and/or walls should be strengthened to sustain roofs in the event of an earthquake. This should be done in a simple and cheap way that the villagers can both afford and follow construction regulations. As in previous earthquakes in Iran, the traditional dome shaped water reservoirs in Tabas region (a simple dome built directly on the ground without walls), stood up without damage (Fig. 6) and the dome vault houses showed a better resistance to earthquakes than barrel vaults (Fig. 5). These observations should be considered during re-designing of the adobe structures in Iran.

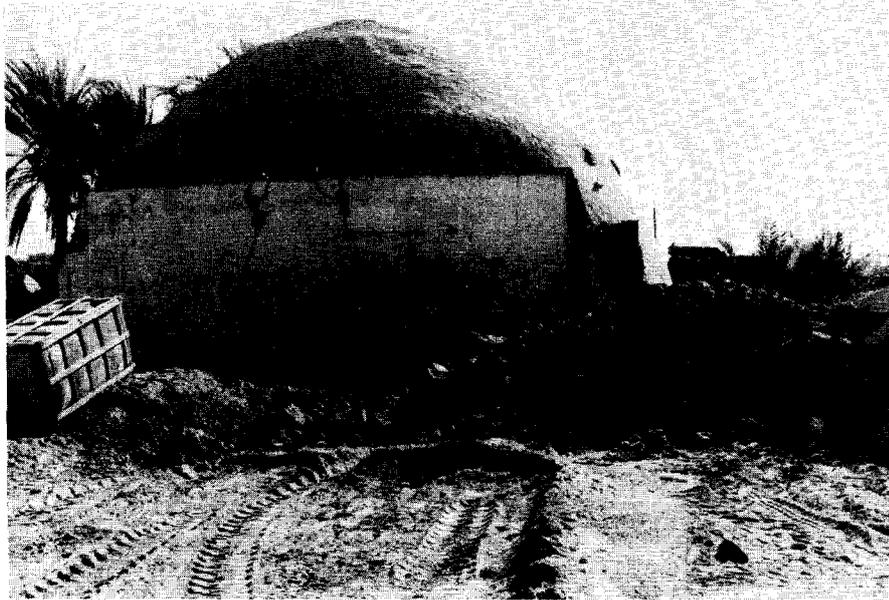
Fig. 6. Traditional domed water reservoir in Tabas is one of the few constructions which did not collapse during the earthquake.

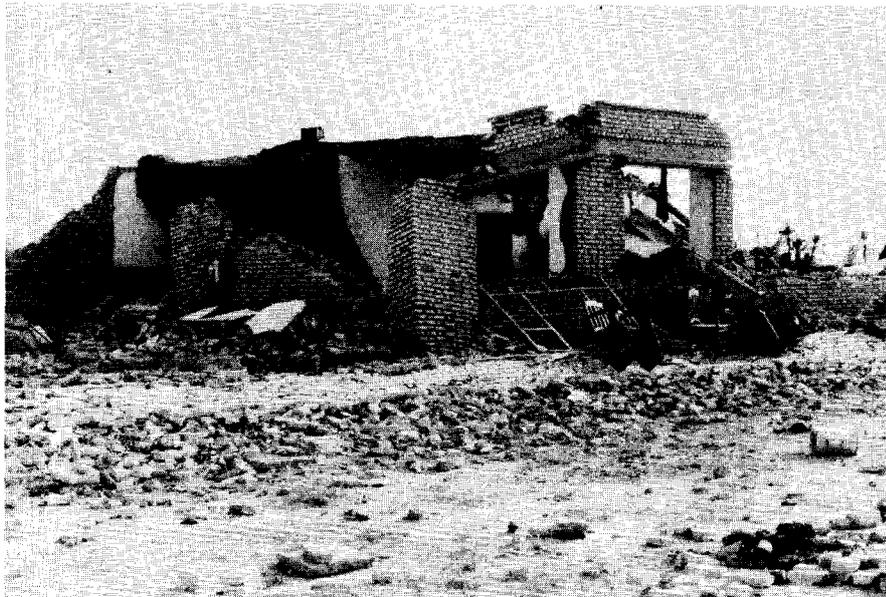
Fig. 7. Steel concrete frame school with arch-type roof at Tabas. Collapse started at the shallow roots of the columns.

frame or ring supported the steel-beam jack-arch type roof. In this case there was no anchor between the roof and the reinforced concrete rings. In some cases other reinforced concrete tie-beams were used at the foundations, under the walls. The buildings were usually single storey and relatively good cement mortar was used. This type of composite structure performed very poorly in the badly shocked areas (Figs 7 and 8). The failure mechanism suggests that collapse started at the shallow roots of the supporting columns and at the corners of the buildings. This is followed by loosening and tearing up the steel concrete frame and finally the collapse of the steel-beam jack-arch roofs (Figs 7 and 9). These structures suffered minor damage outside the badly shaken area.

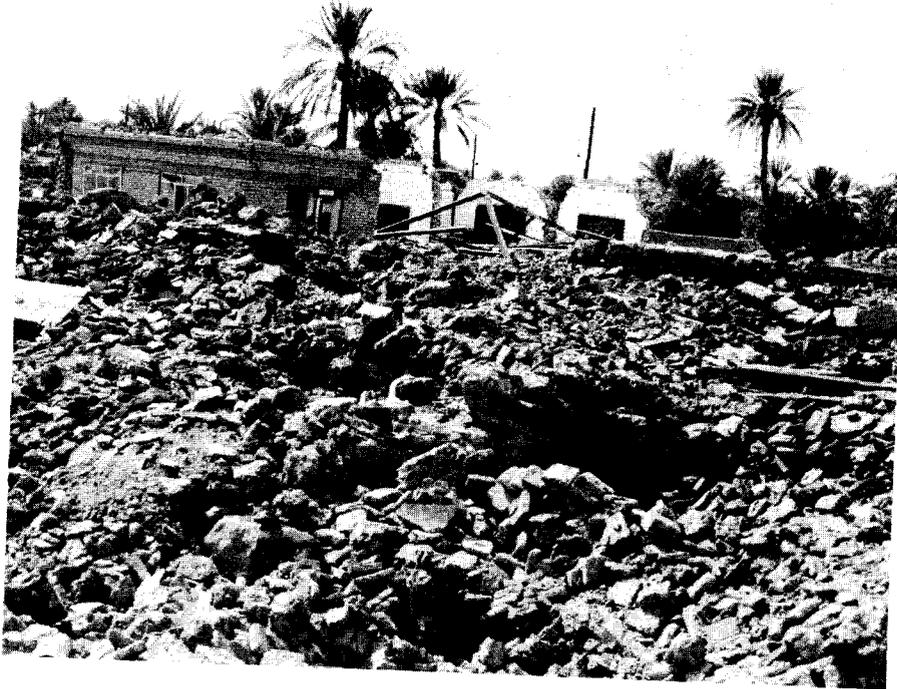
Fig. 8. Failure at steel concrete frame school with arch type roof at Fahalanj (no. 47 in Fig. 1 and Table 1). Note the steel-beams of the collapse roof which were constructed on the sun dried clay bricks.

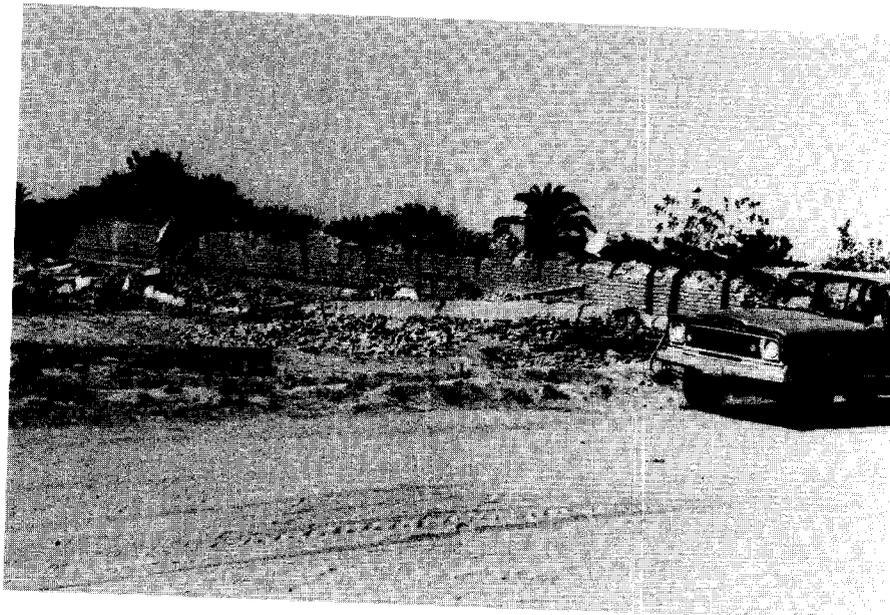
Fig. 9. Complete collapse of the steel-beam jack-arch roof of the brick masonry school at Korit (No. 80 in Fig 1 and Table 1). Note the broken steel concrete ring on the foot of the wall.

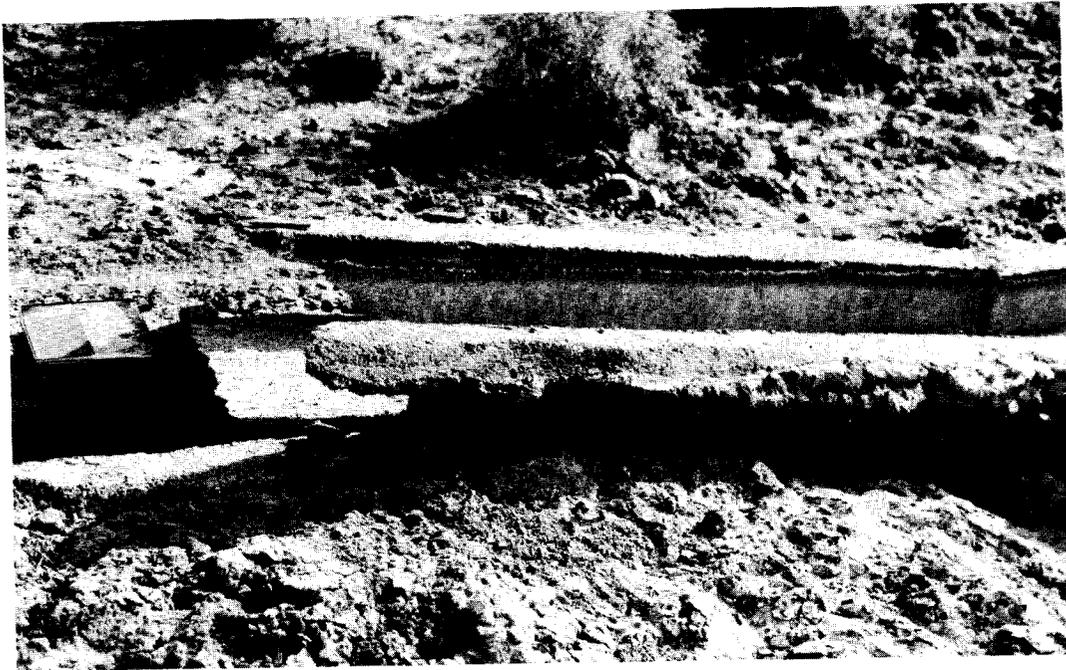
Fig. 10. Displacement of the concrete water canal supplying the Fahalanj region, east of Fahalanj (No. 47 in Fig. 1 and Table 1).

The elevated steel water tanks which were not full during the earthquake, survived and suffered little damage. Usually the bracing rods in the upper panel were cut or the tank slightly tilted. A 5 km concrete water canal constructed on the clay beds east of Fahalanj village (No. 47 in Fig. 1) broke and was displaced at 60 points (Fig. 10).

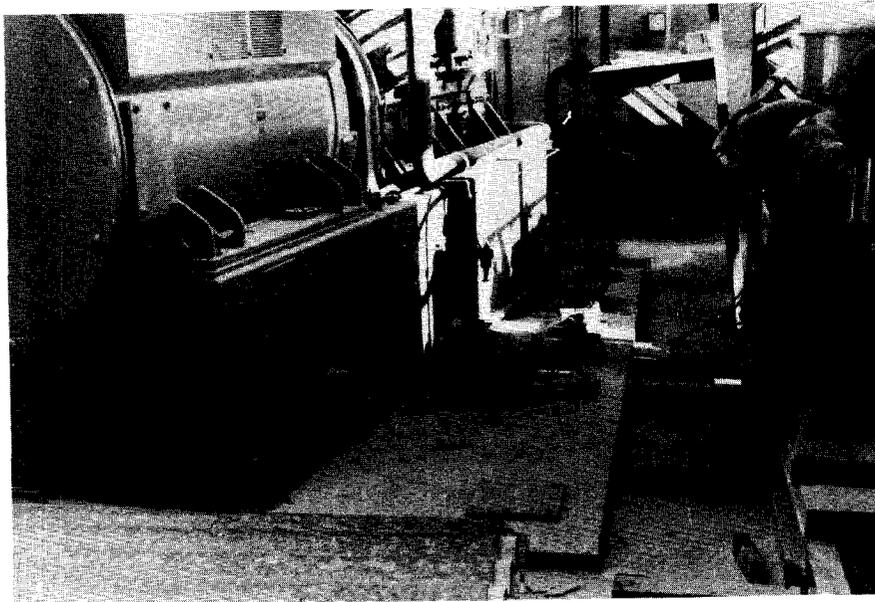
Fig. 11. Eastward shifting of Tabas power generator during the earthquake.

Heavy objects like the Tabas power generator (of more than 50 tons weight) and the diesel reservoir-tank of the Tabas Power Station (containing 50,000 litres of diesel at the time of earthquake) were shifted eastwards about 80 cm and 17 cm respectively during the earthquake (Fig. 11). The latter stopped, after 17 cm displacement, by hitting a wall. A less heavy generator in Tabas Power Station did not break its bolts and

did not move during the earthquake. This earthquake is of major engineering significance since it provided evidence of the ground motion characteristics of a large event. The response of simple heavy objects to ground motion during the earthquake becomes the controlling event for the design of structures with high safety requirements in Iran, e.g. nuclear power plants.
